Manhole Inspection Summary

Manhole # S41I__051MH

Insp Date: **5/14/08 9:23 AM**

Location Address: **side of 1419 bank st**

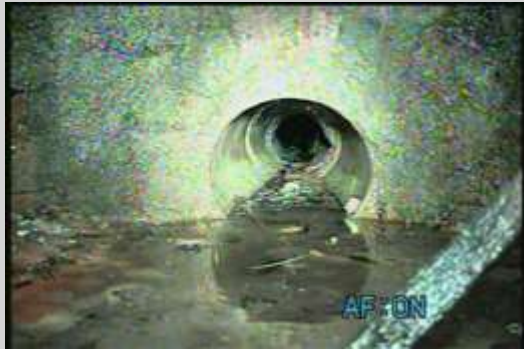
12 O'Clock Outflow

8 in. Circular Gravity Sewer
Pipe Out @ 12 O'Clock

Infiltration: **None** Pipe Seal Cond: **Unknown**
